QUPPER MOUNT GLEN LAKE DAM

PHASE I INSPECTION REPORT

NATIONAL DAM SAFETY PROGRAM

NJ 00202

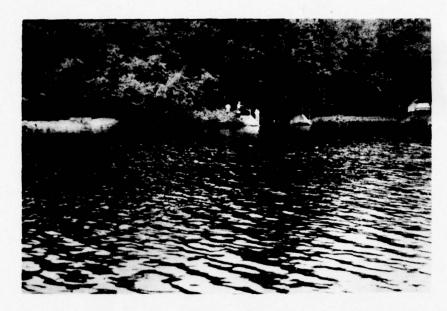
Photo 1 - View of dam and spillway from reservoir left shoreline.

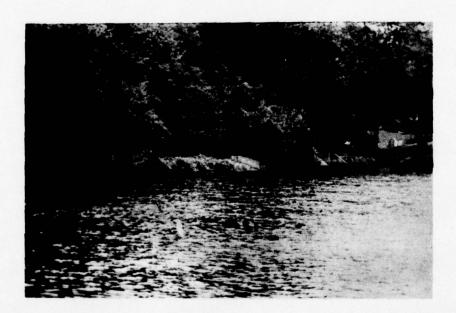
Photo 2 - View of dam from shoreline near left abutment.

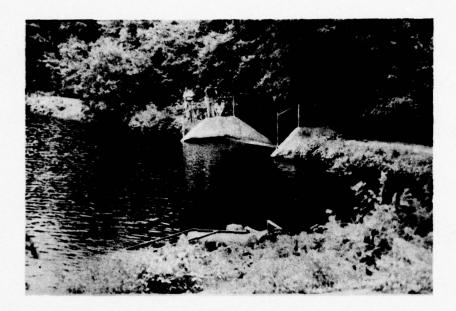
Photo 3 - View of dam and spillway from right abutment.

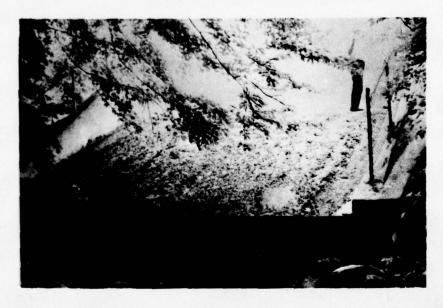
Seepage was visible under the concrete spill-way chute cutoff wall. A small leak was observed where the spillway contacts the left wing wall. The spillway crest concrete and the spillway chute floor concrete are in good condition. There is no cracking of the concrete and all construction is in alignment. The chute walls are in acceptable good condition.

Photo 4 - View of spillway chute from downstream discharge channel.

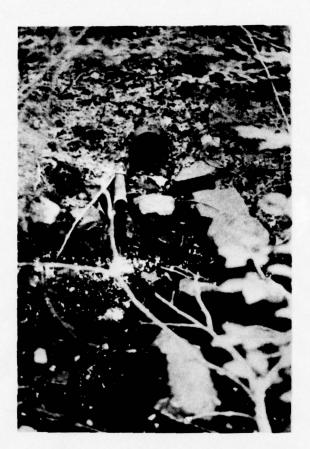
The inlet was submerged and could not be inspected. The last foot of the pipe at the outlet is exposed and is badly corroded with some holes in the pipe wall. Perhaps 50 percent of the original material remains.

The exposed end of the low level outlet pipe is severely eroded. The condition of the pipe under the embankment could not be observed and is unknown.

Photo 5 - Discharge ends of low level outlet pipes.

Inspection of the condition of the outlet pipe under the dam should be done within 30 days and repairs, if necessary, should be completed within 90 days.

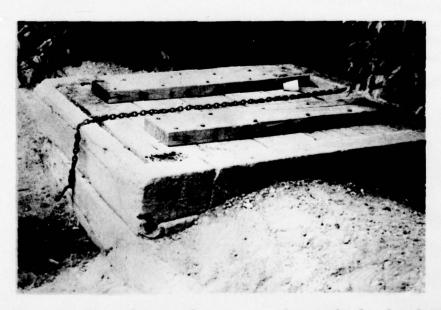
Photo 6 - View of top and cover on valve vault for low level outlet pipes.

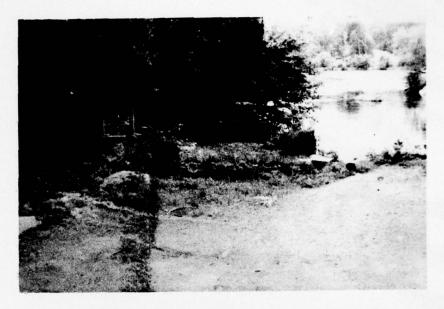
Photo 7 - View of small discharge channels cut through right shoreline beyond right abutment.

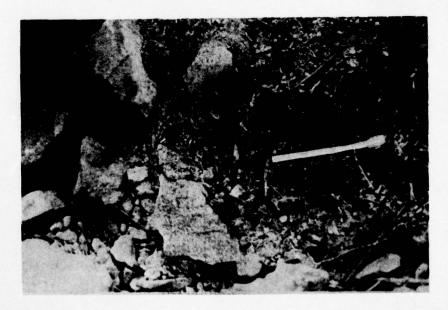
Seepage was observed in four locations at the toe of the embankment. One seep, approximately 15 feet in width, was observed about 50 feet from the left end of the dam. Seepage was estimated at 2 to 3 gpm and was flowing clear. Another seep about 10 feet wide was observed about 25 feet left of the spillway. The seepage in this area was estimated at 2 gpm, was located immediately left of the spillway. Standing water was observed along the embankment toe in the section right of the spillway.

Photo 8 - Flowing seep at toe of slope immediately left of spillway.

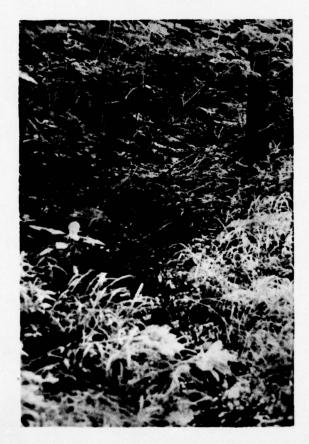
Photo 10 - Seepage area located 50 feet left of spillway.

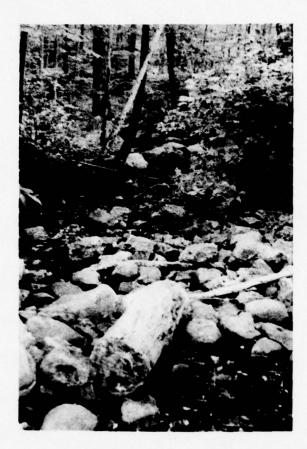
Photo 11 - Discharge channel at spillway.

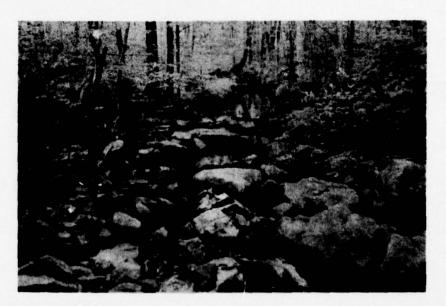
Photo 12 - Discharge area downstream of spillway.

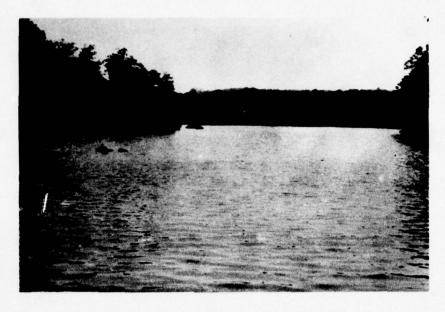
Photo 13 - View of lake with dam on left side of picture.
